Super Roof

Coating Gives Superdome
a Bright New Look

ICONIC MERCEDES-BENZ SUPERDOME IN NEW ORLEANS SPORTS ITS BRIGHTEST LOOK YET

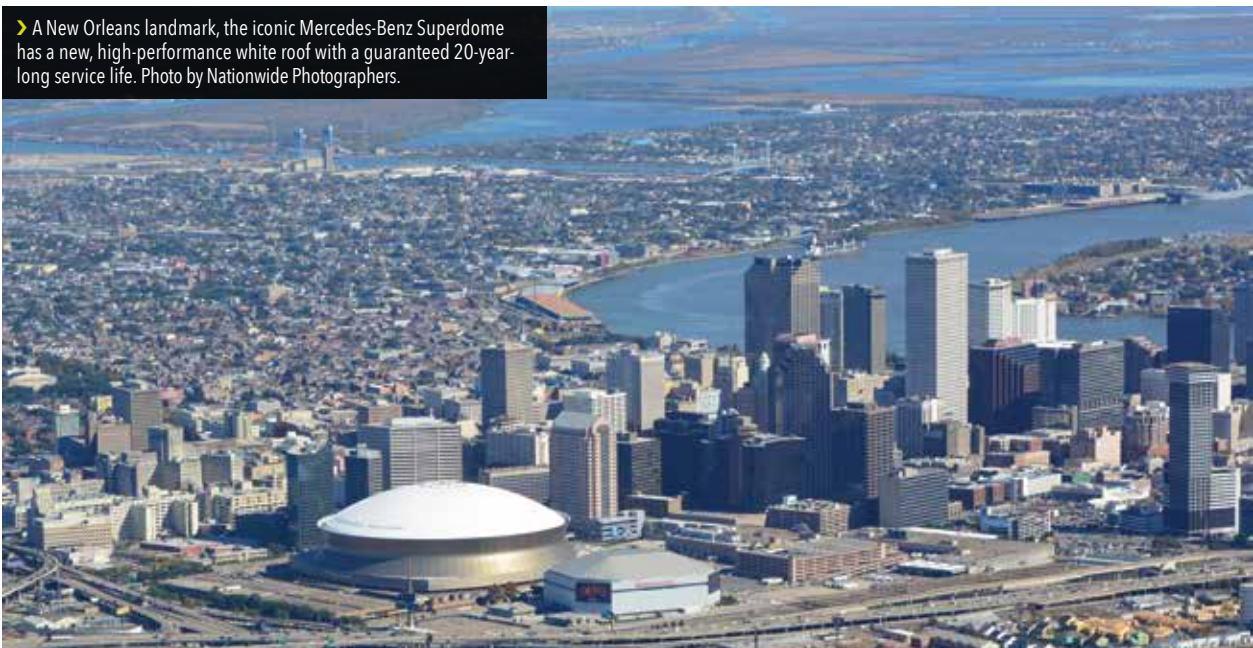
► A New Orleans landmark, the iconic Mercedes-Benz Superdome has a new, high-performance white roof with a guaranteed 20-year-long service life. Photo by Nationwide Photographers.

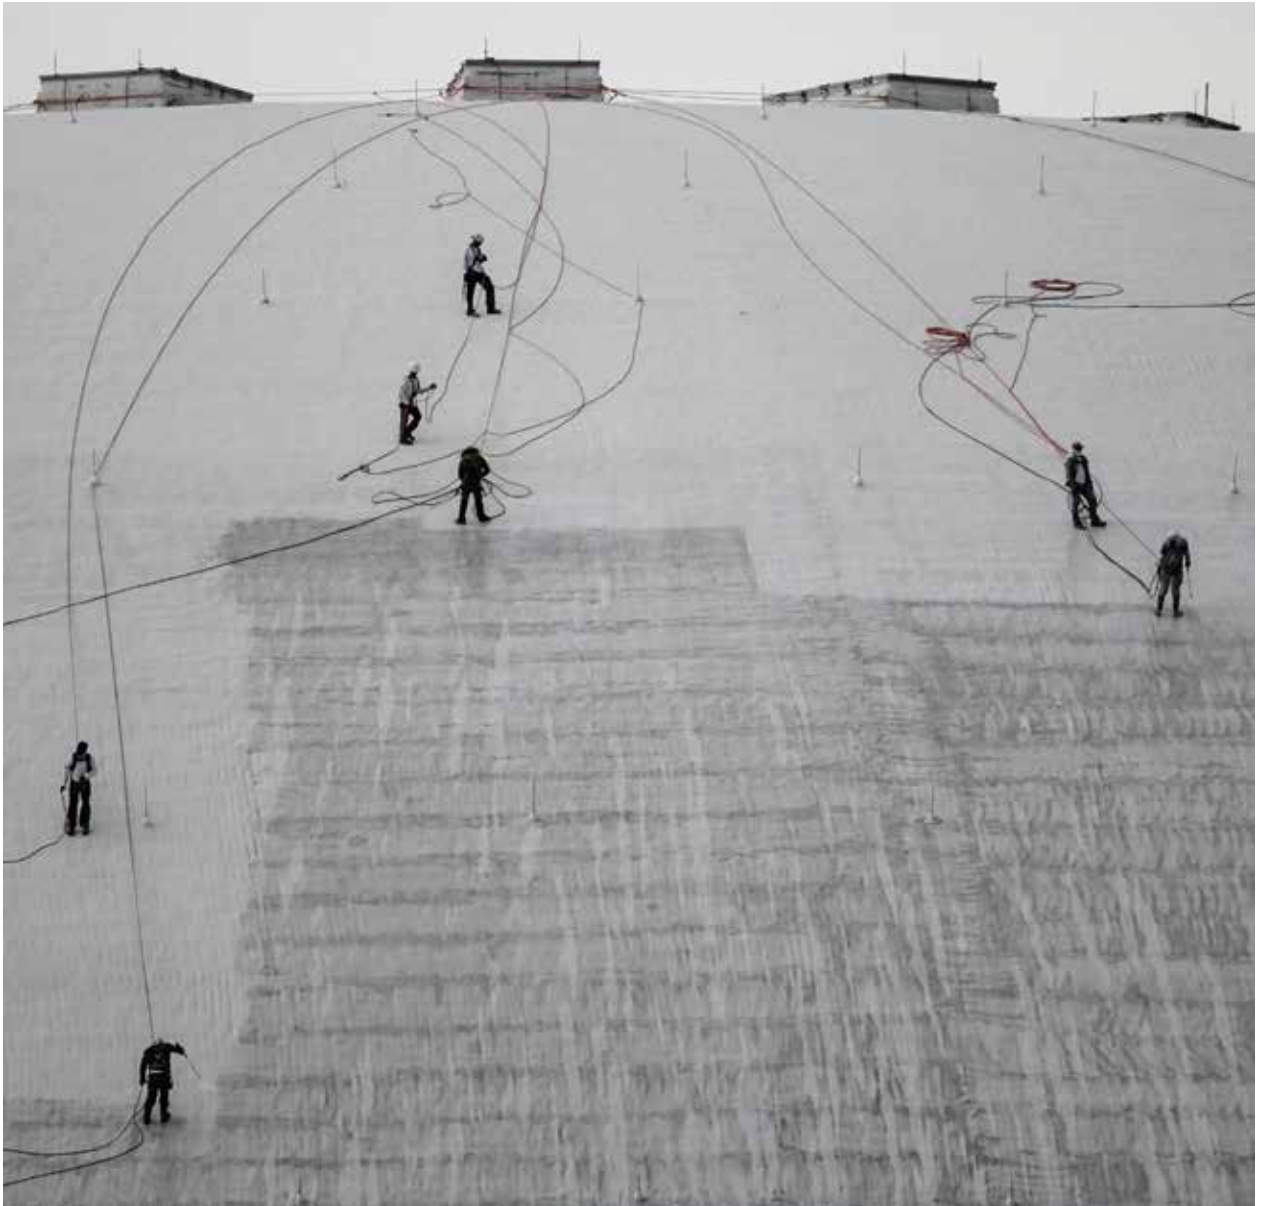
› The re-coating job started with a thorough pressure washing of the entire 9.6-acre roof to remove dirt and buildup of biological growth. This two-week cleaning helped prep the surface much better for the subsequent coating applications. Photo by David Grunfeld, NOLA.com/The Times-Picayune.

First, United Cleaning Concentrate was used to power wash the roof. The next step was applying one layer of Kymax solar gray basecoat. Before its application, Tom Keller,

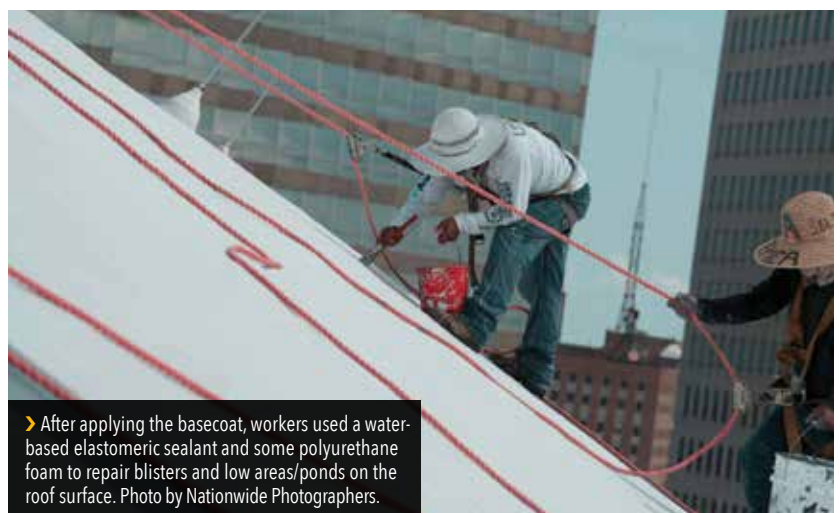
humid environment, combined with the Superdome's urban location downtown, meant the roof needed a coating that could resist the buildup of dirt and biological growth. In 2013, with the expiration on the roof's 10-year warranty approaching in addition to some blistering and ponds appearing on the roof, SMG New Orleans initiated the recoating project.

› After applying the basecoat, workers used a water-based elastomeric sealant and some polyurethane foam to repair blisters and low areas/ponds on the roof surface. Photo by Nationwide Photographers.

After the basecoat was applied, low areas, ponds and blisters were repaired with polyurethane foam and Roof Mate™ Buttergrade, a water-based, high-tensile strength elastomeric sealant. Working again in 16 pie sections, the workers then applied two white Kymax topcoat layers in a similar fashion but at a much lower rate of 6 wet mils each. “It was basically a mist coating,” said Keller. “Our applicators are used to spraying on a much thicker layer of coating, and so I told them to approach their work more like painting a car than applying a roof coating. We used smaller tips and had no issues with applying the topcoats at all.”

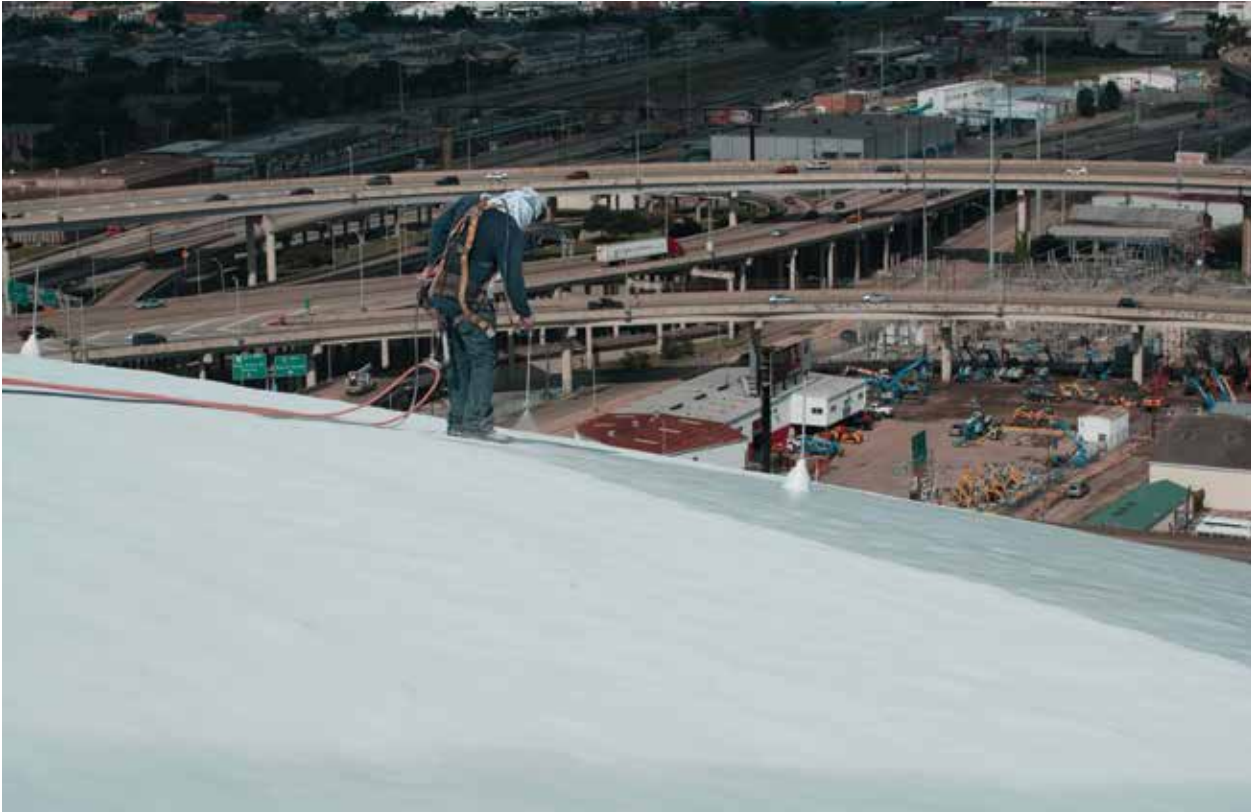
Workers sprayed on two Kymax® topcoats at a rate of 6 wet mils. This coating is designed to be weatherable and to have cool roof properties. Photo by Nationwide Photographers.
